Guidelines for
**Preservation, Stewardship
& Development**

Guidelines for the
Preservation, Stewardship, and Development
of the
Dimock Community Health Center Campus
55 Dimock Street
Roxbury, Massachusetts

Prepared by August Associates, Architects
under contract with
Historic Boston Incorporated
with partial financial support through the
Boston Landmarks Commission
from the City of Boston
Neighborhood Development and Employment Agency
Community Development Block Grant funds.

November 1984

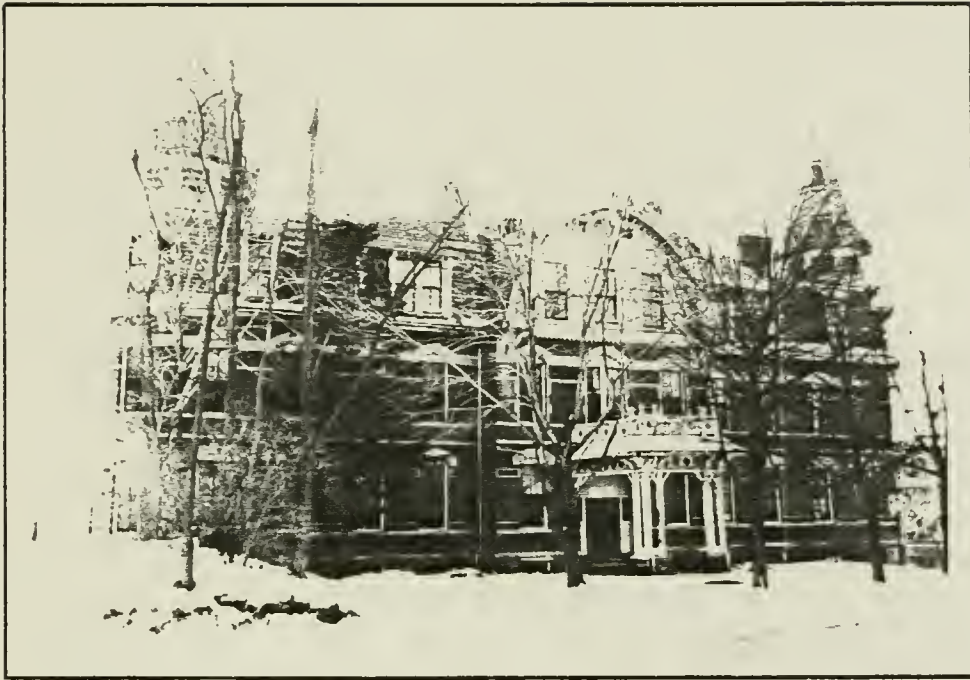
Zakrzewska Medical Building

Building in worst condition. Roof in very bad shape. Number 1 priority

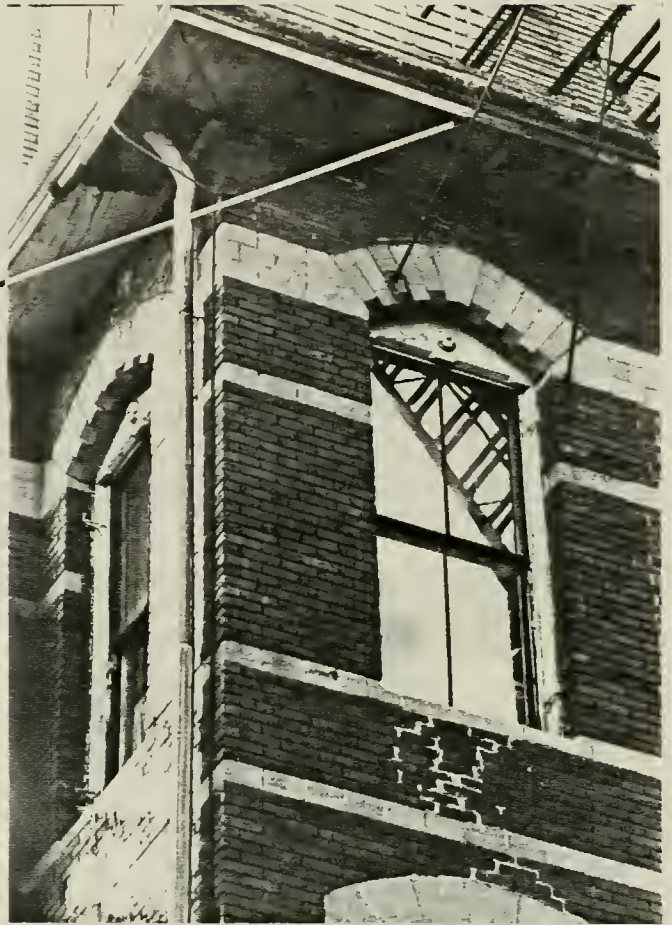
27

Wooden gutter and soffit area in need of repair

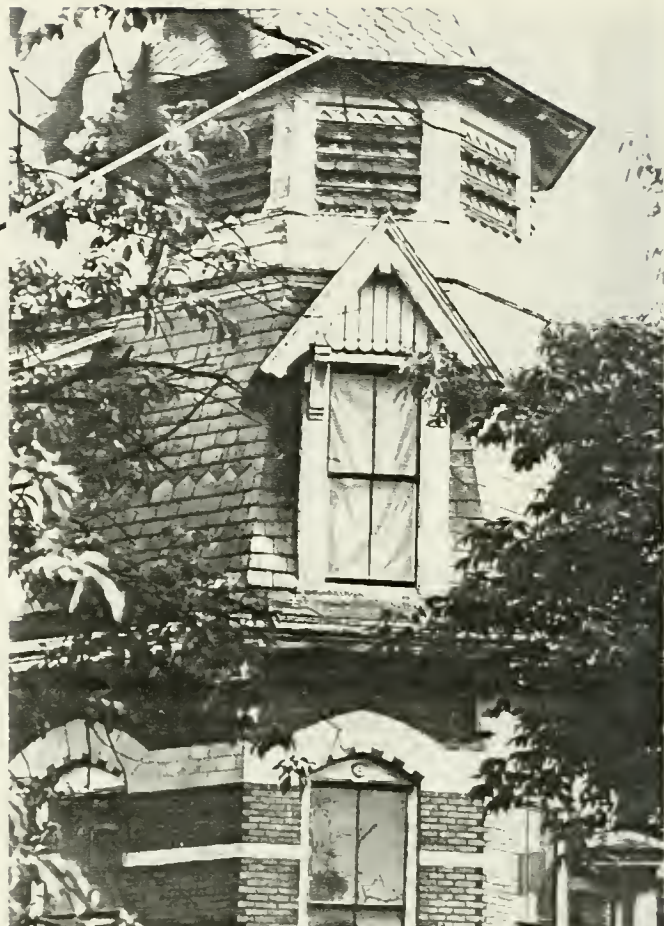
29

Wooden gutter and bracket in need of restoration

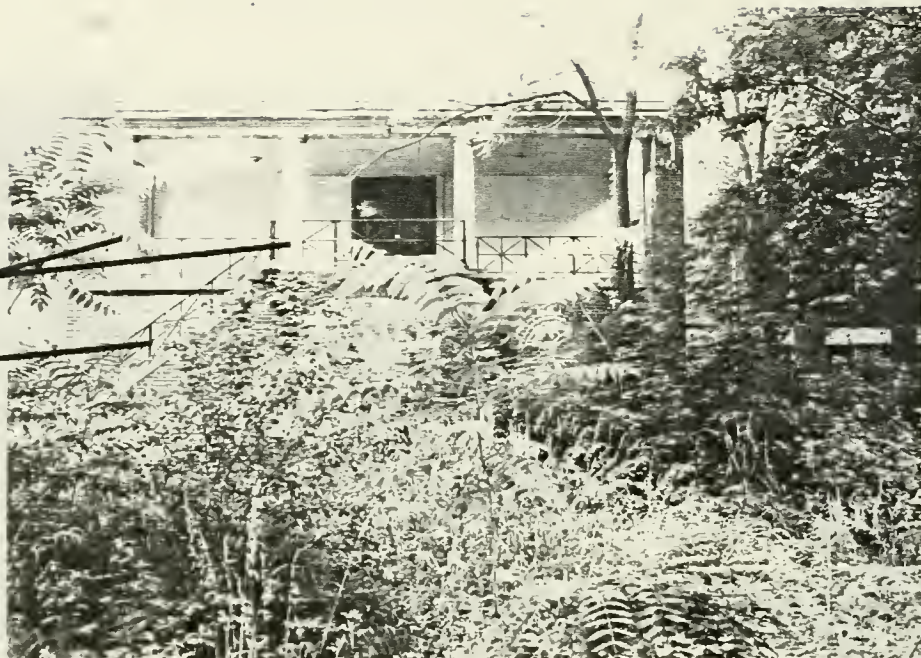
48

Downspout leak

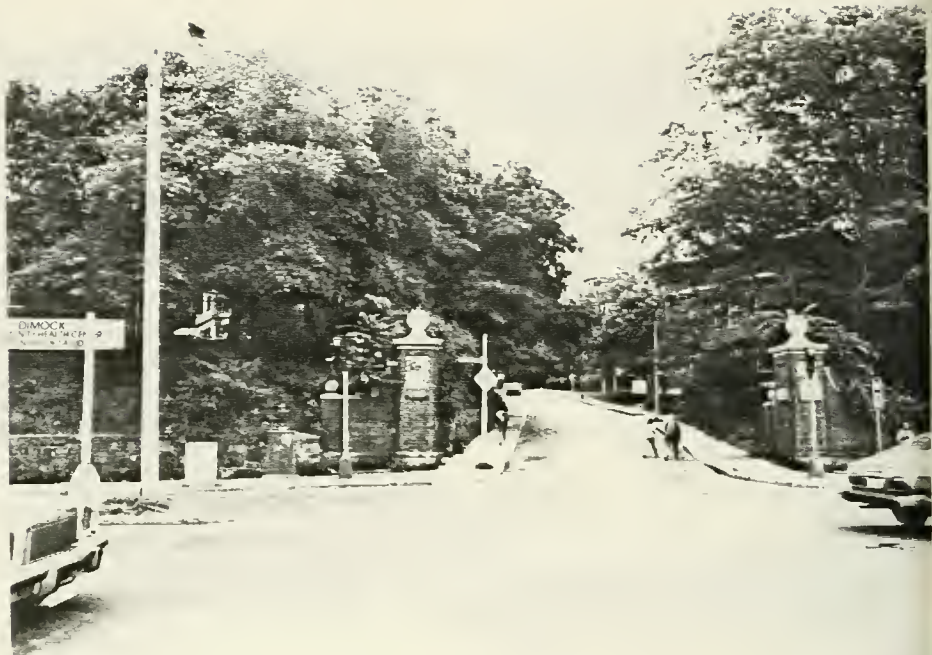
100

The Dimock Community Health Center sign should be on the brick entrance piers and not on the hill. The brick work and the stone wall need to be tuck-pointed.

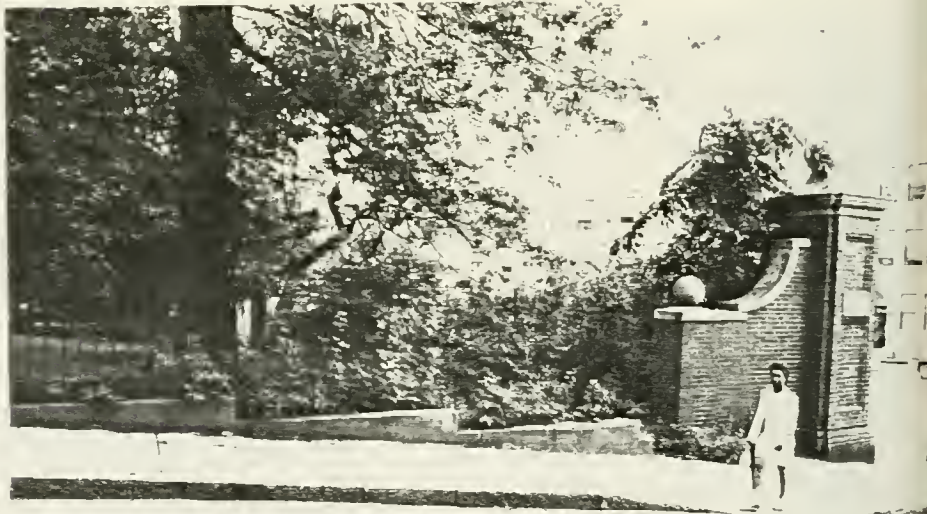
101

The iron fence needs to be repaired and/or replaced.

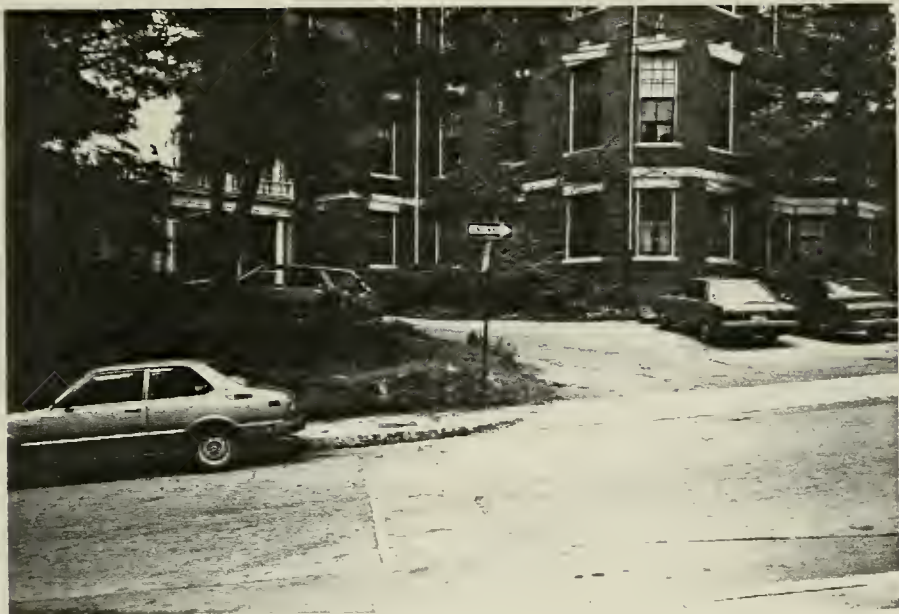
113

The Cheney entrance needs a better approach. This could be achieved by a narrower curb cut on Dimock Street.

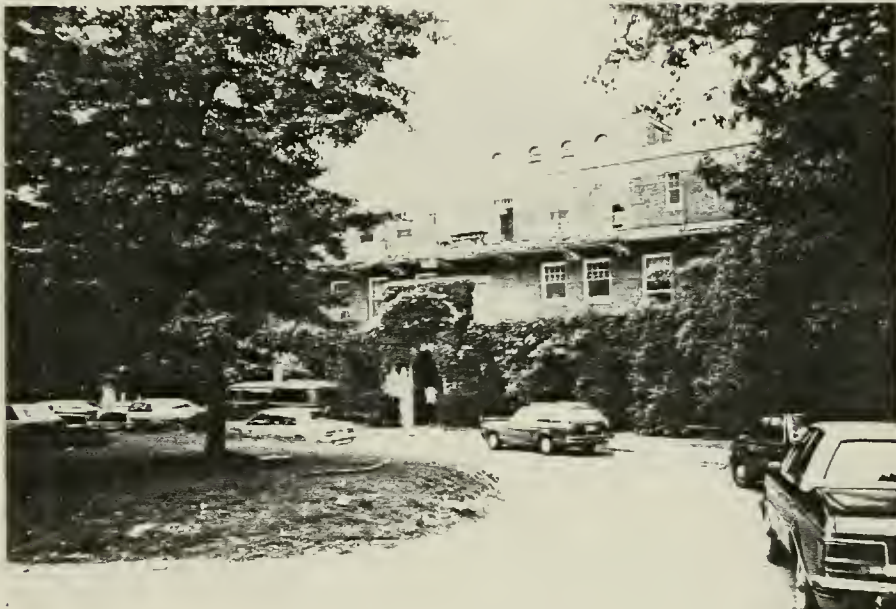
114

The vines obscuring the building lines should be removed. The road edge at the island need maintaining. A replacement tree (Pinoak) should be planted in the island.

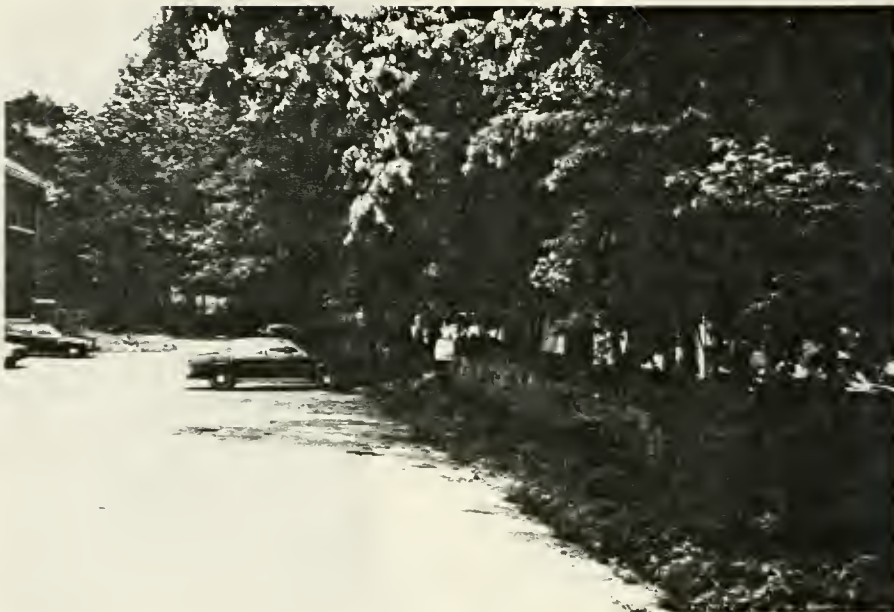
119

The east wall is nicely reinforced by deciduous trees. The wall needs to be tuck-pointed and the mowing strip maintained or replaced with groundcover.

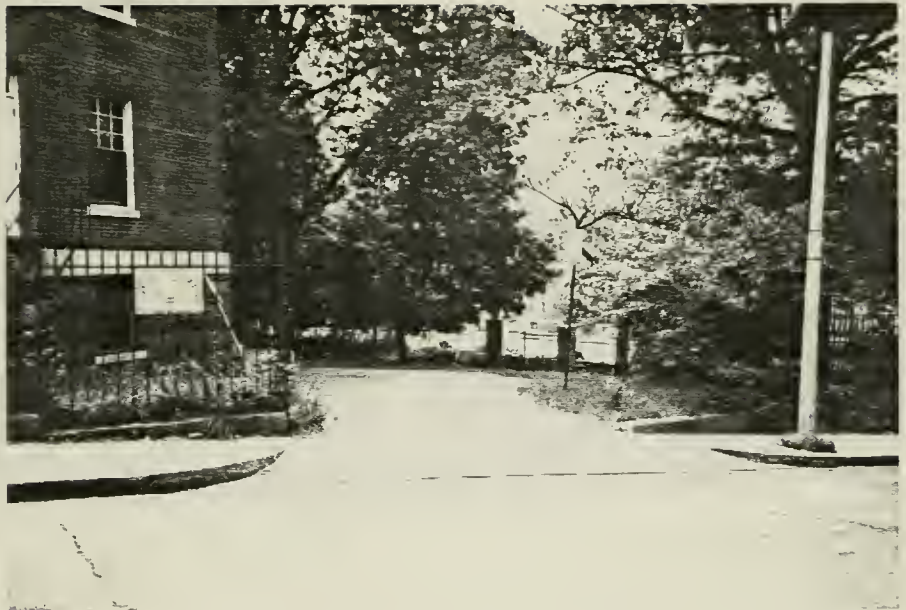
121

Iron fence should be continued to the drive.

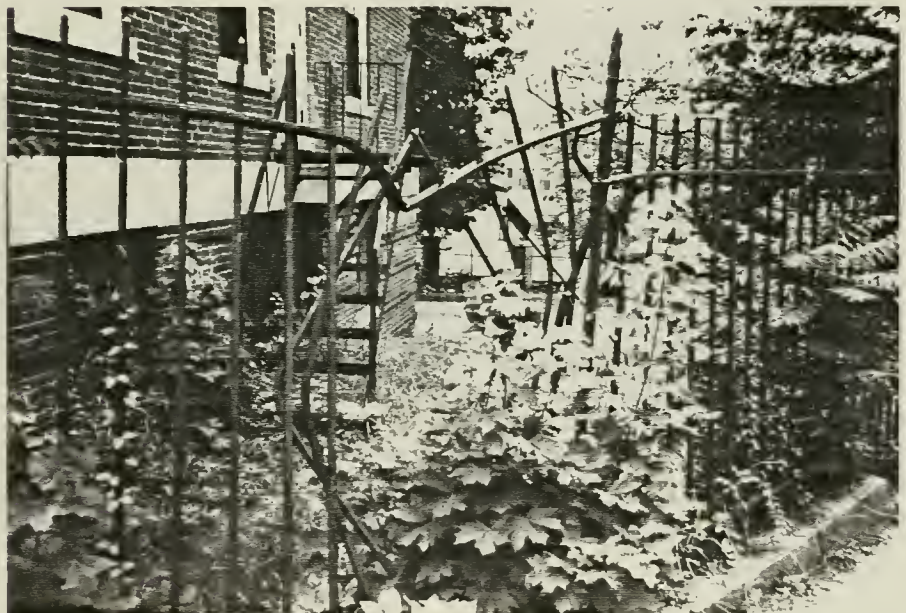
122

Fence repairs should be made and plants removed from the fence line.

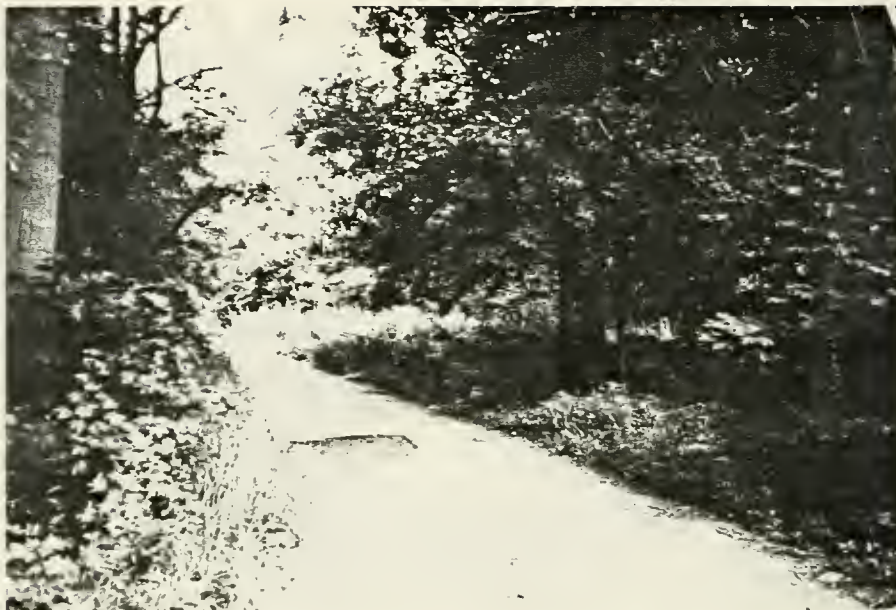
139

Trash from road edge to be removed, limbs pruned to give view across landscape, and road edge mowed.

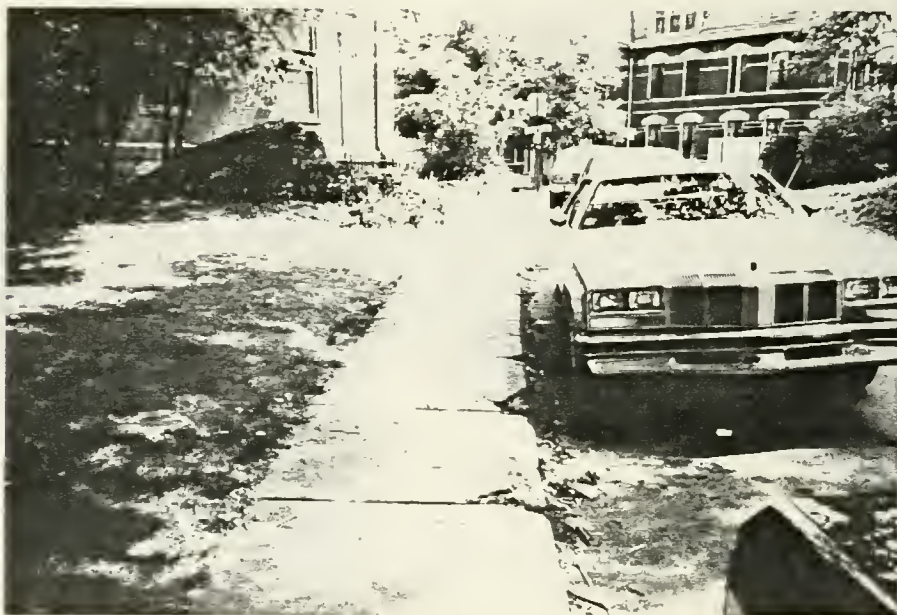
140

Sidewalk and curb needs to be repaired.
